**COMBAT MAINTENANCE CONCEPTS AND REPAIR  
TECHNIQUES FOR HELICOPTER AIRFRAME STRUCTURES**

Thomas N. Cook  
John Accashian  
Richard E. Corbelle

Sikorsky Aircraft Division  
United Technologies Corporation  
Stratford, Connecticut 06602

Final Report for Period September 1979 - July 1980

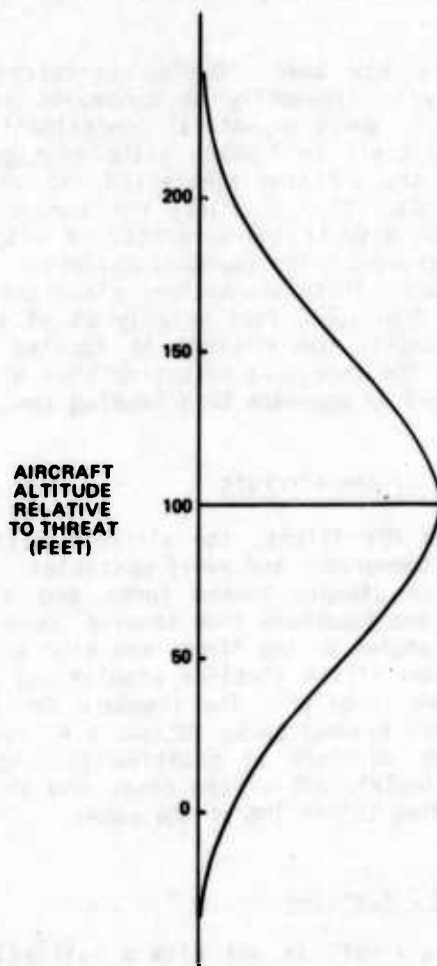
Figure 15. Assumed Distribution of the Aircraft Altitude Relative to the Threat

the ground-based threat (Figure 15). The standard deviation in altitude was assumed to be 50 feet. This implies that 2% of the time the aircraft will be flying below a threat situated on elevated terrain. Only 2% of the time would the aircraft be operating at an altitude of 200 feet or more above the threat.
